Manhole Inspection Summary

Manhole # S55C1_003MH

Insp Date: **9/5/08 11:04 AM**

Location Address: **mertens ave**

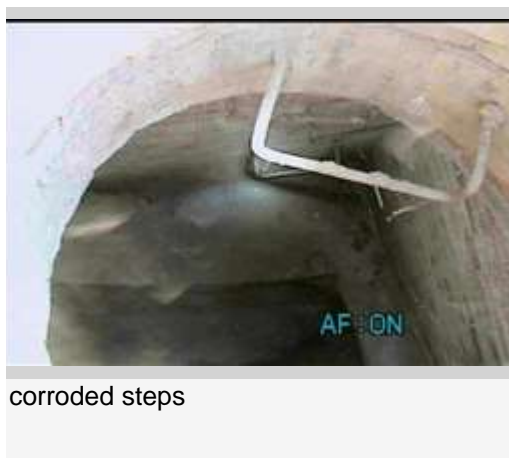
Defect 1

Count: **4** Missing: **0** ☒ **Corroded**

corroded steps

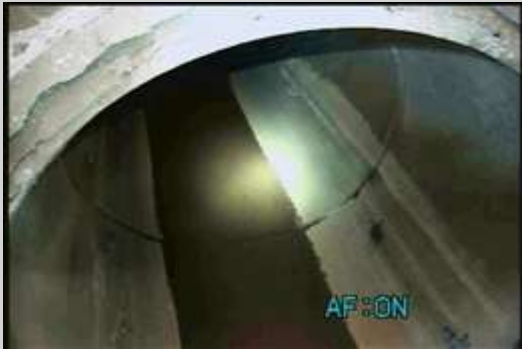
12 O'Clock Outflow

48 in. Circular Gravity Sewer
Pipe Out @ 12 O'Clock

Pipe Material: **Concrete** ☐ Pipe Lined

Invert Depth: **11.30** (ft.) Flow Characteristics: **Slow**

Infiltration: **None**

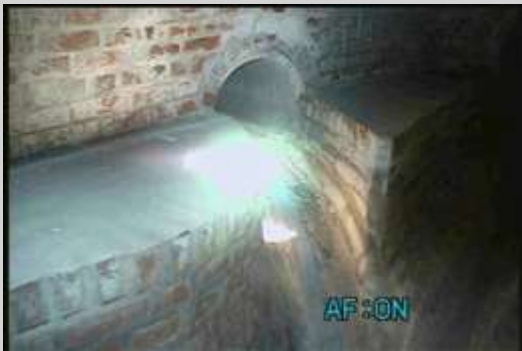
4 O'Clock Inflow

18 in. Circular Gravity Sewer
Pipe In @ 4 O'Clock

Pipe Material: **Clay** ☐ Pipe Lined

Invert Depth: **10.88** (ft.) Flow Characteristics: **None**

Infiltration: **None**

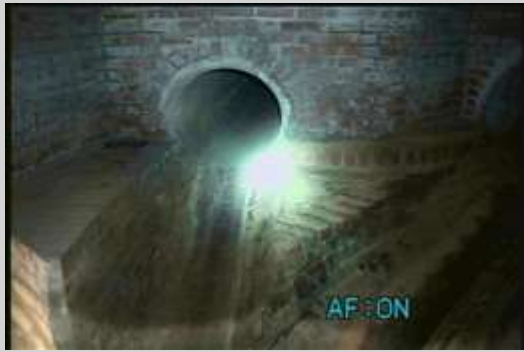
5 O'Clock Inflow

18 in. Circular Gravity Sewer

Pipe In @ 5 O'Clock

Pipe Material: **Clay** ☐ Pipe Lined

Invert Depth: **10.92** (ft.) Flow Characteristics: **None**

Infiltration: **None** Pipe Seal Cond: **Unknown**

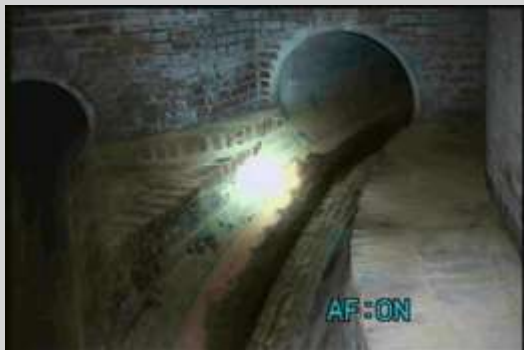
6 O'Clock Inflow

18 in. Circular Gravity Sewer

Pipe In @ 6 O'Clock

Pipe Material: **Clay** ☐ Pipe Lined

Invert Depth: **10.63** (ft.) Flow Characteristics: **Slow**

Infiltration: **None** Pipe Seal Cond: **Unknown**
